UNDUGU'S MATHARE SCHOOL RENOVATION PROJECT - 2015
PICTURE GALLERY - THE FRONT PART OF THE TUITION BLOCK

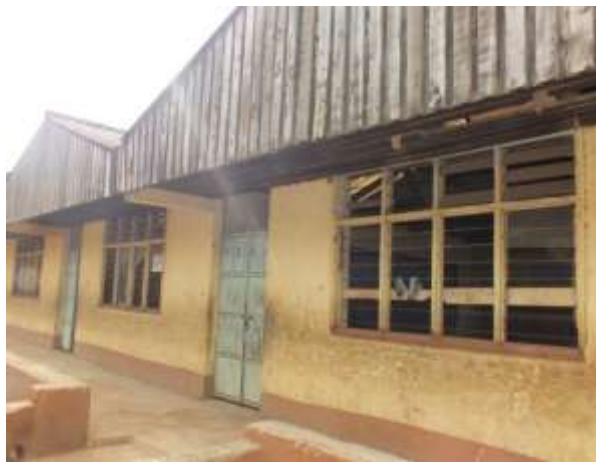
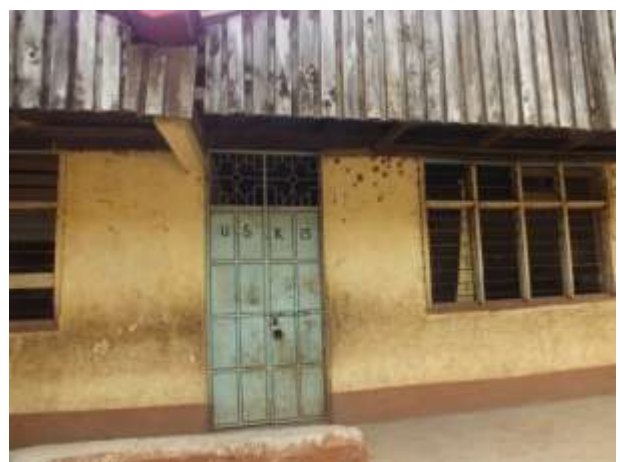
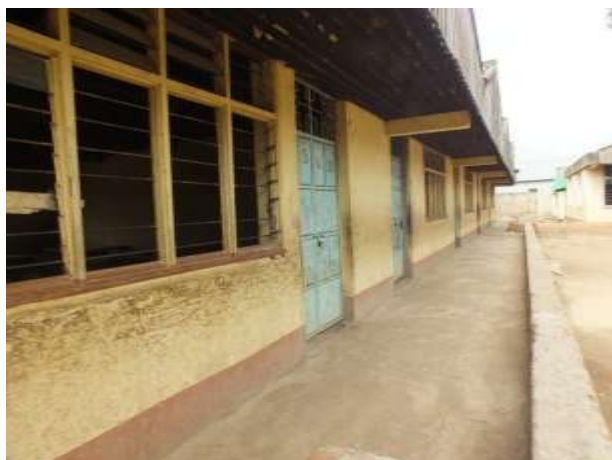
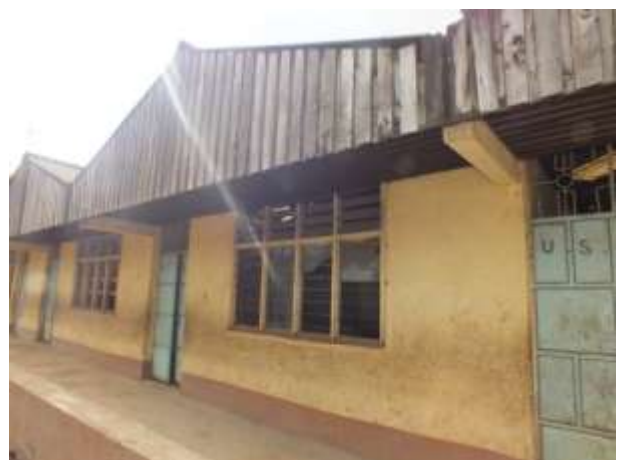
The tuition (classroom) block front elevation - before the renovations.....

Although the walls were painted two years ago they had become dirty because they were not originally smooth-plastered, they were left rough, thus easily collecting dust and looking dirty all the time. The windows were of wooden (timber) frames and the glass louvers either fell off or were broken over the years, since USK has had no funds to renovate them. The ceiling in the corridors are made of wooden trusses, many of which have rotted or were broken over time, giving prowlers access to the classrooms through the roof. On one occasion one learner fell and was injured when he climbed onto this ceiling for fun and the weak trusses gave way to his weight. It has been impossible to keep anything valuable in these classrooms because it was very easy for thieves to break in and steal anything in sight. For this reason no books or teaching aids (even blackboard chalk or duster) were kept in the classrooms. They were only brought in during lessons and taken back for storage immediately after the lessons in the head teacher's office.

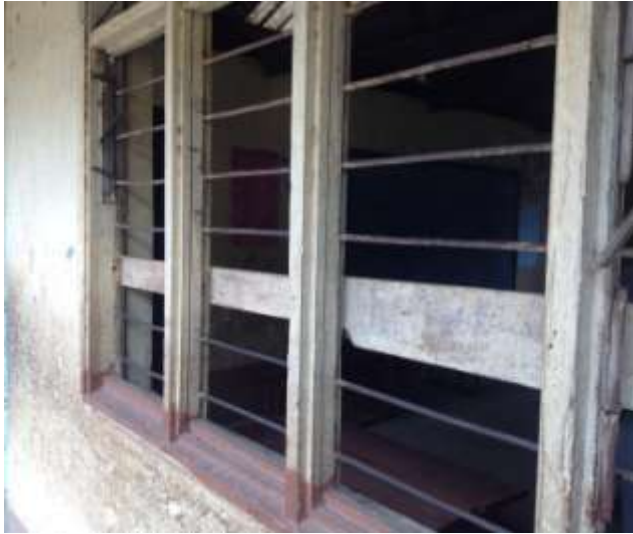
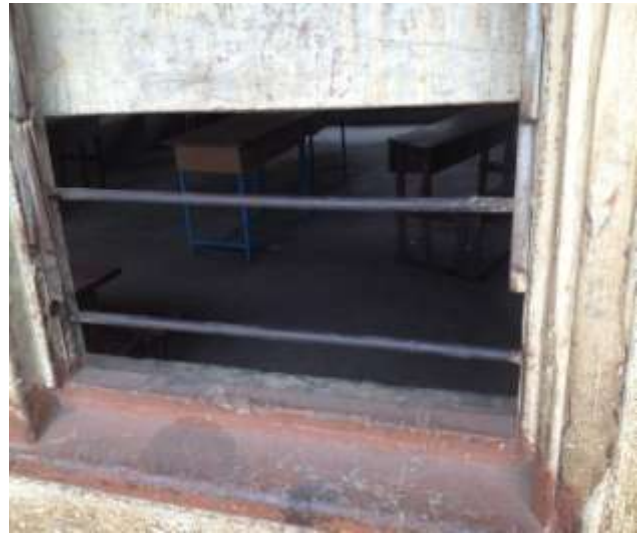
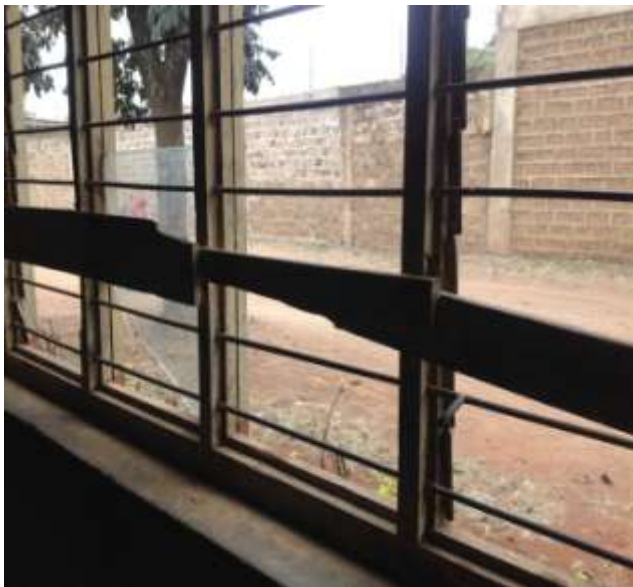
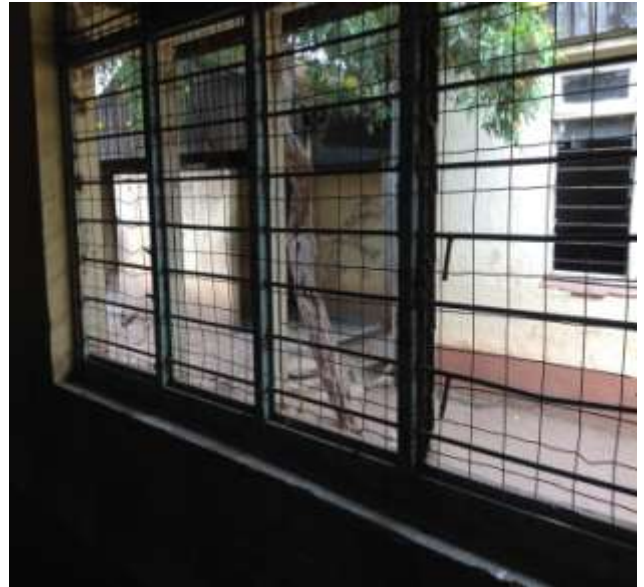
The tuition block front elevation - at the beginning of the renovations.....

The window panes were all broken and the metal bars and frames had seen better days. The renovations saw the removal of these old wooden window frames.

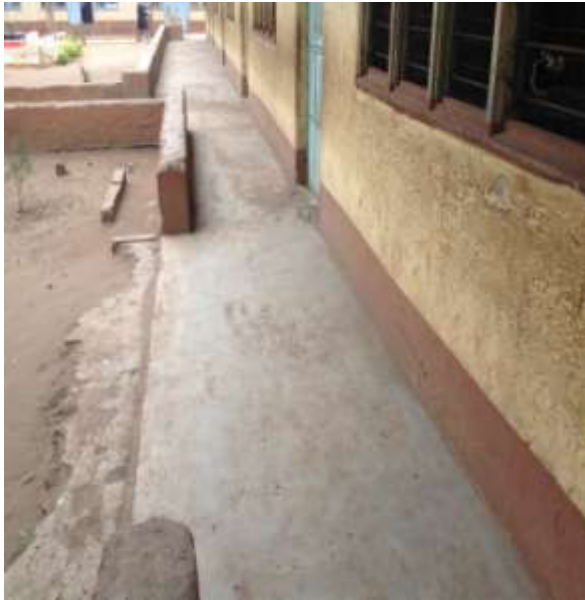
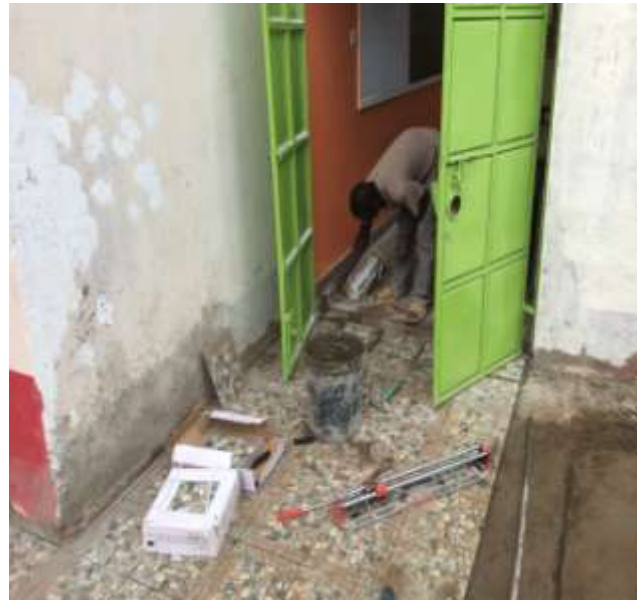
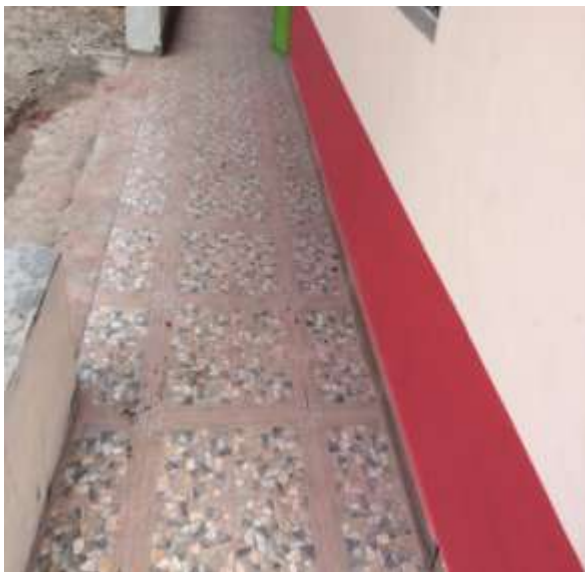
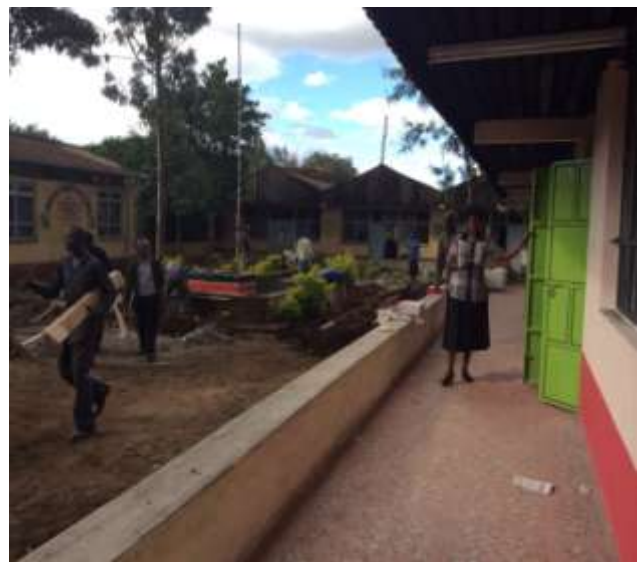
The tuition block front elevation - during the ongoing renovations.....

The corridors were worn out and full of potholes. The worn out screed here was removed and fresh screeding done after which they were dressed with ceramic tiles (with matching skirting against the walls) spilling out from the new-look classroom floors described elsewhere in this report.

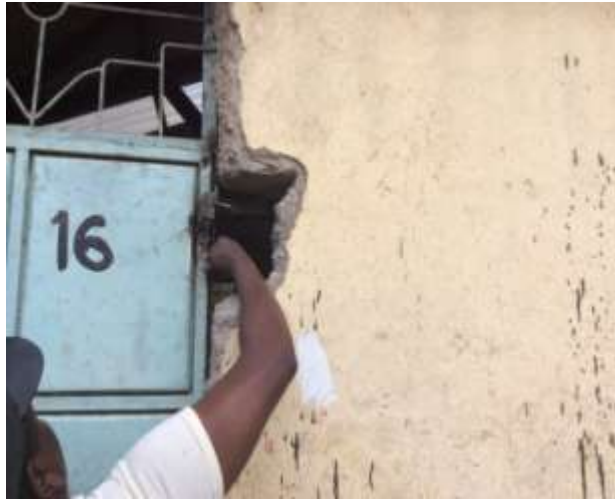
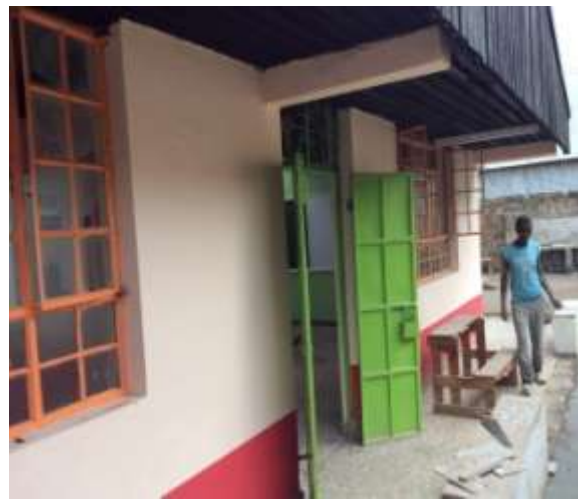
Tuition block front elevation - ongoing renovations continued.....

The classroom doors were originally designed to open inwards, a serious risk in the event that a stampede occurred and children needed to rush out of the classrooms for safety. If this had happened they would all have been stuck at the doors, unable to escape. Luckily this has never happened. These classroom doors have now been removed and re-installed so that they open outwards for improved escape opportunities for the learners, in case of any fracas, stampede or commotion.

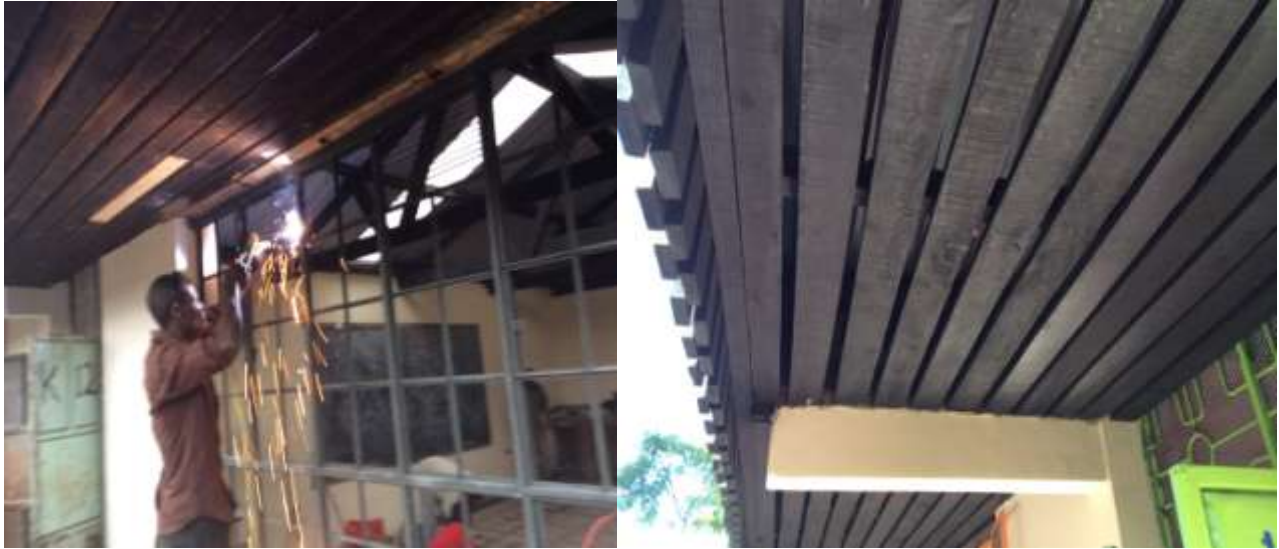
Tuition block front elevation - ongoing renovations continued.....

The rotten and broken wooden ceiling trusses of the verandah have been replaced with new ones and, together with the roof canopies and other wooden parts of the roof that are deemed strong and have been retained, all wooden parts have been freshly treated with a chemical solution that protects them against rotting and termite invasion.

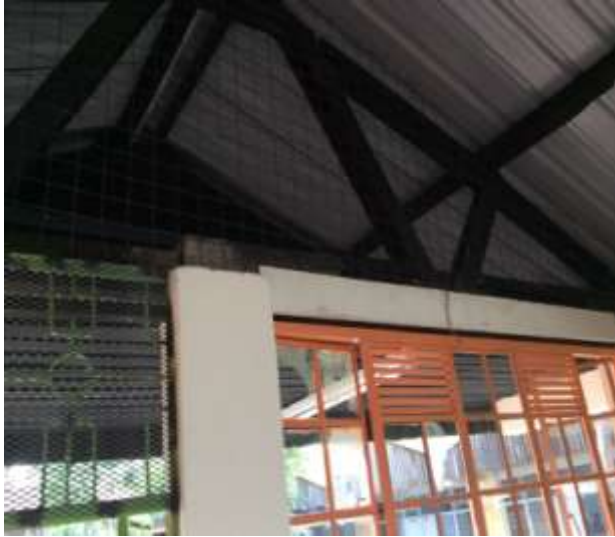
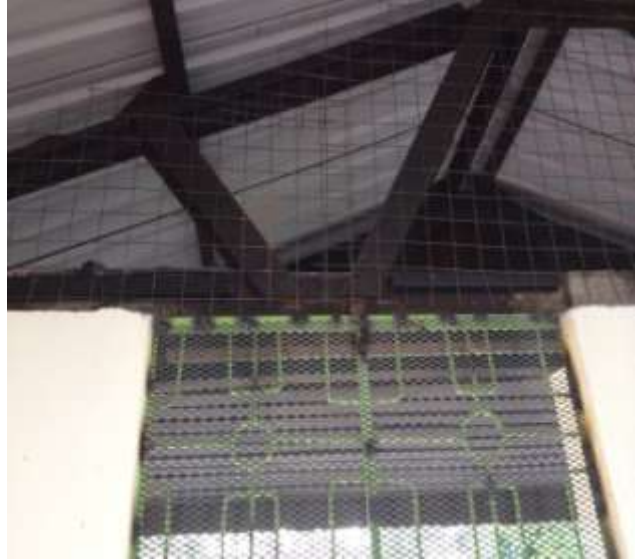
The classrooms were designed with no ceilings and the roof gable space was open. This has now been sealed with wire mesh, again to deny burglars and thieves access to the classrooms, and also to deter naughty learners from climbing up into the verandah ceiling using the top frame of the doors as one of them did before.

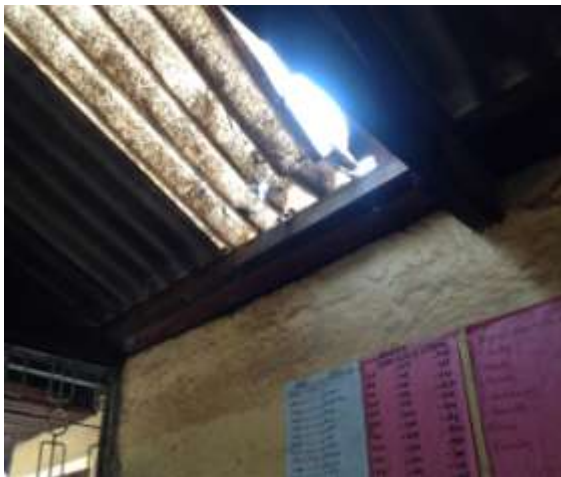
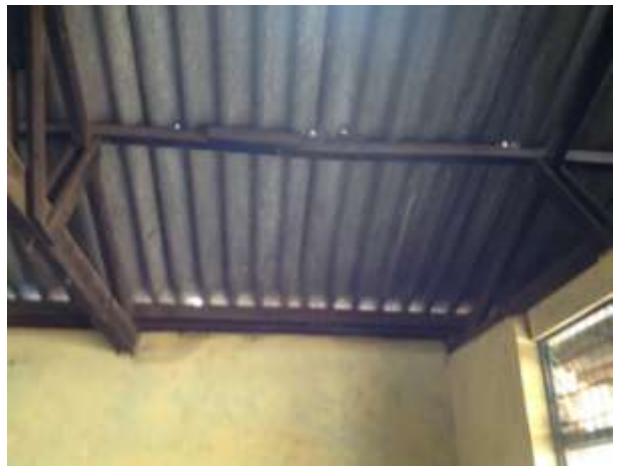
Tuition block front elevation - ongoing renovations continued.....

The whole asbestos roof of the tuition block was damaged and leaking in most parts as seen in the two pictures below...

Now the entire asbestos roof of the tuition block has been removed and replaced with new aluminium zinc pre-painted sheets, with a thickness of gauge 28. These new roof sheets will now enable the harvesting of rain water to supplement the water supplied by the Nairobi City County and reduce the frequent water shortages experienced in the area.

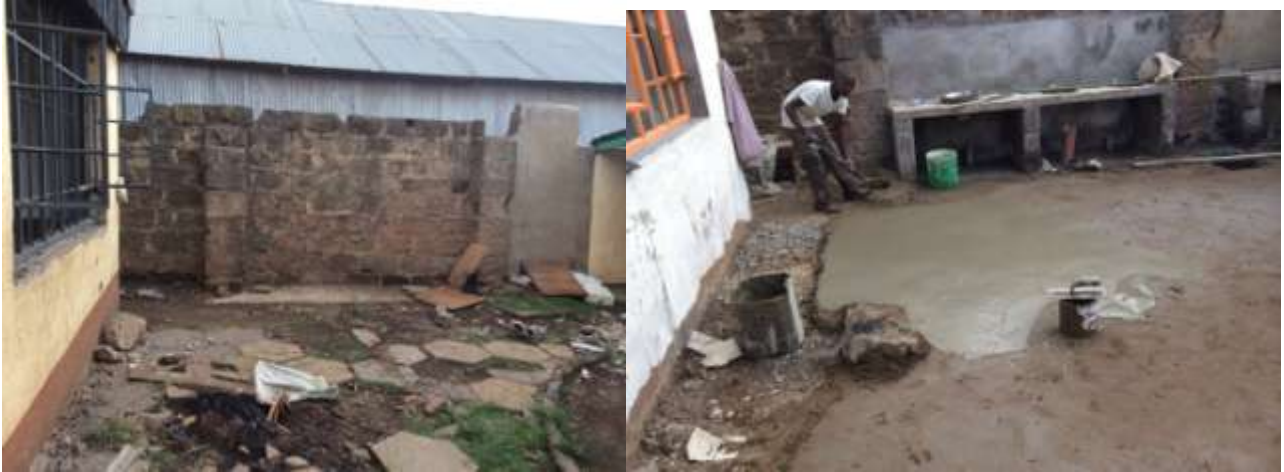
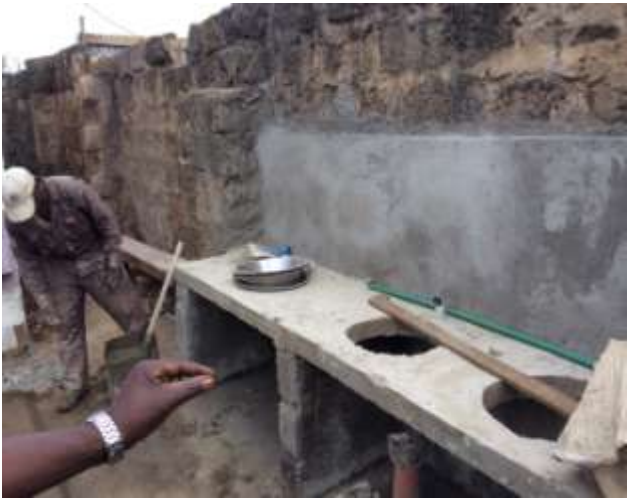
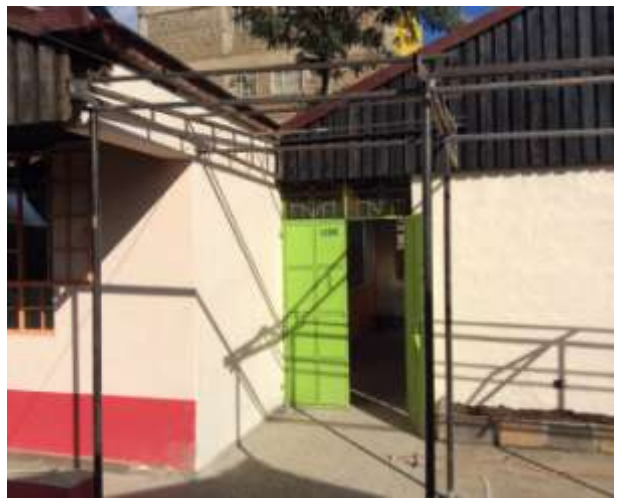
The open area outside the learners' washrooms...

The ground here was very rough and unkempt. It has now been leveled and screeding has been applied to the surface. A hand washing counter that will have taps and sinks has been created and the building of a canopy to shield the learners from rain as they walk from the classrooms to the washrooms has been initiated.
