## UNDUGU'S MATHARE SCHOOL RENOVATION PROJECT – 2015

### PICTURE GALLERY 2 – The sanitation system and staff rooms

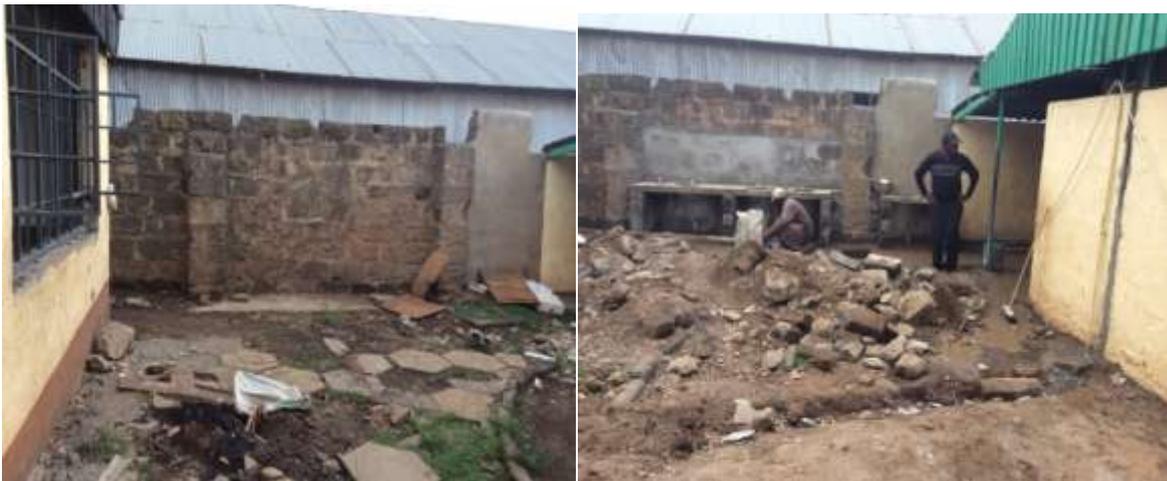
This is what the pathway leading to the toilets from the tuition block looked like before the renovations. Although not provided for in the current budget, it would have been awkward to leave this section as is, after giving the tuition block the facelift that it has undergone.

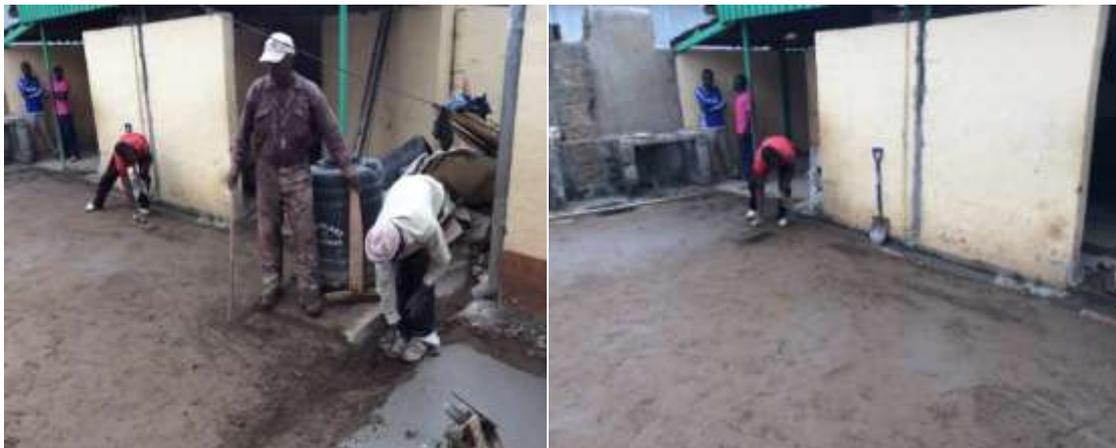
The rubble here was therefore cleared away and leveling done to give way to a smooth pavement.

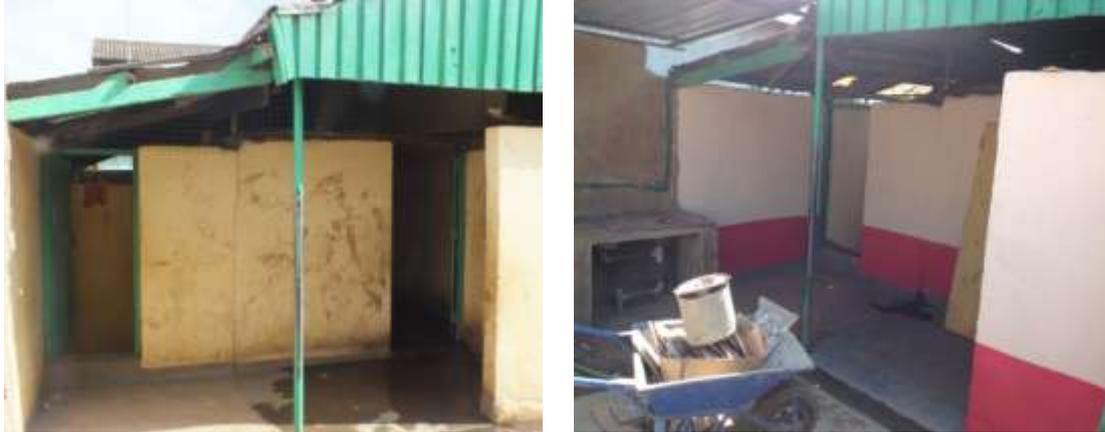
The toilet block walls were painted, although a slab will be created in Phase Two of the project, to support smaller overhead water tanks that will directly serve the toilets.

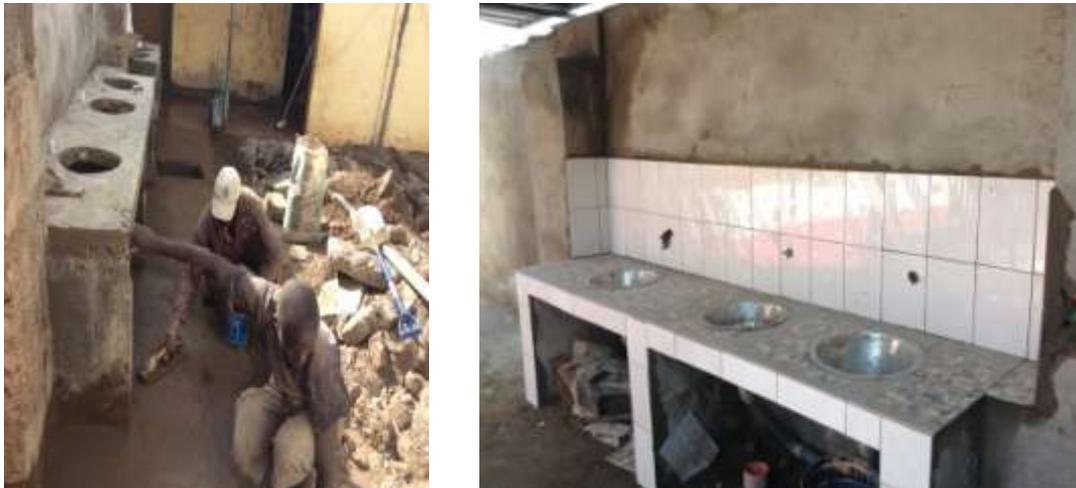
A handwashing basin counter was created in this pathway, with old sinks (that were originally in the classrooms) fitted on it. The learners will now be encouraged to keep their hands clean at all times to avoid infections and diseases associated with dirt (currently the Ministry of Health has announced an outbreak of Cholera in Nairobi, a highly contagious disease that is precipitated by dirt, germs and lack of hygienic living conditions).

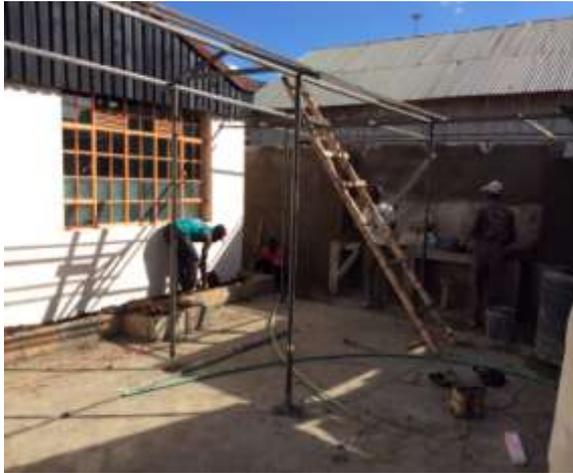
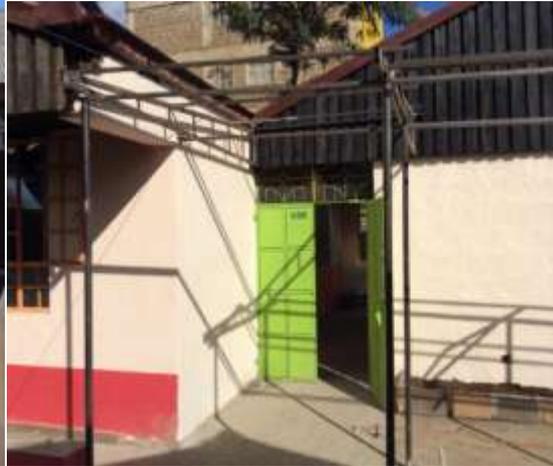
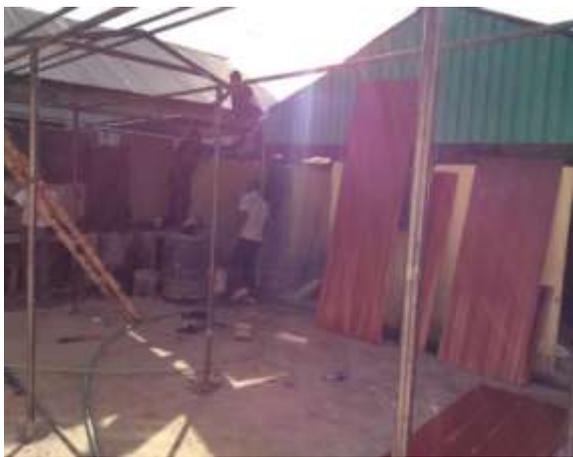
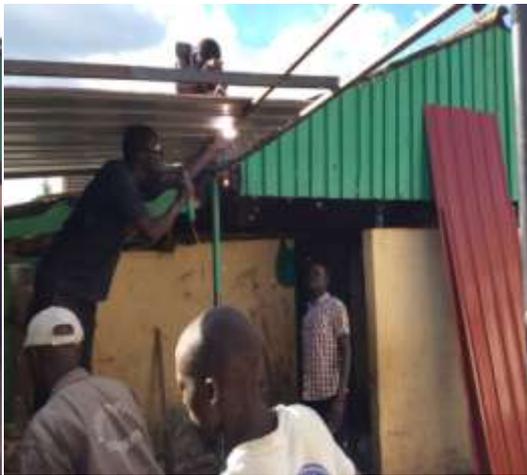
After removal of the rubble and screeding was completed, the construction of a canopy was initiated by erecting an RHS metal framework running from the classroom block to the toilet block.

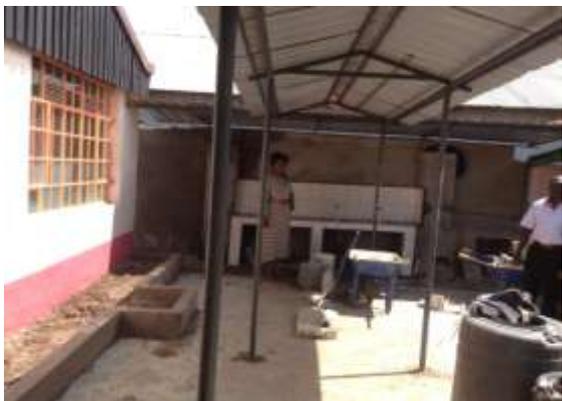
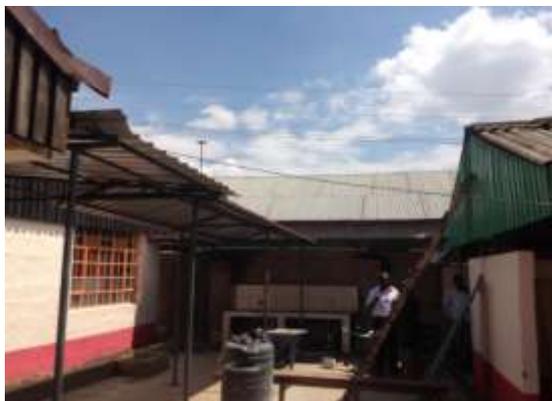
Once the framework was completed aluminium sheets (gauge 28) were mounted onto it forming a canopy that will protect the learners from the rain when they go to the toilets from their classrooms and when they go to wash their hands.

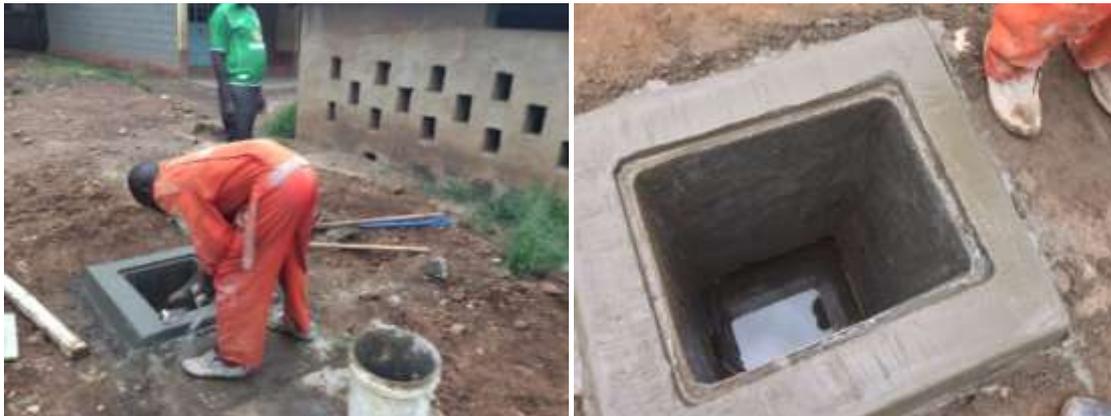
The whole sewer system leading to the school compound was characterized by blockage not only in the drainage pipes but also at the manholes. These manholes' covers had all been stolen, exposing the drainage passages to all kinds of solid matter and soil, preventing any liquid from passing through the narrow pipes. This renovation project created a brand new foul drainage system bypassing the old pipes and connecting new larger diameter pipes from the abolition block to the main city sewer. This involved digging brand new trenches for laying the new pipes, refurbishing the existing manholes and creating additional manholes to allow for more inspection points, thereby eliminating long spells of blockages as was experienced before.

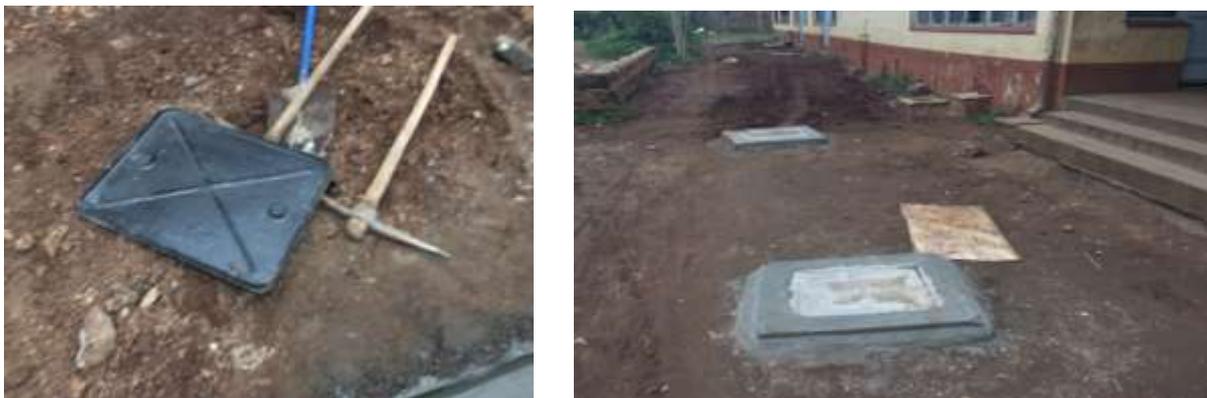
Metal manhole lids were purchased and will be secured with metal cages to prevent thieves from stealing them again.

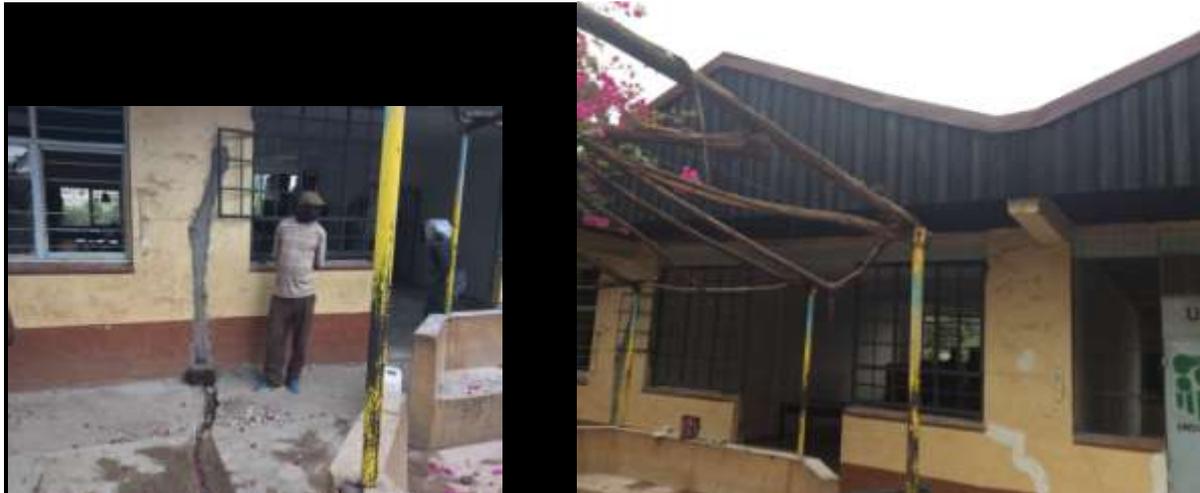
The head teacher's office shares a wall with the old staff room. There were two other rooms and a toilet next to the old staff room that were in a deplorable condition. The temporary partitioning of these three rooms was dismantled to make one big room that will now be used as the new staff room. The old staff room will now be used by the deputy headteacher and the two social workers attached to this school. The other teachers will now use the newly expanded room next to the old staff room. Like the tuition block, this block received a facelift of the roof, where aluminium sheets replaced the original asbestos roof. New electrical ducts were laid and missing fittings replaced.

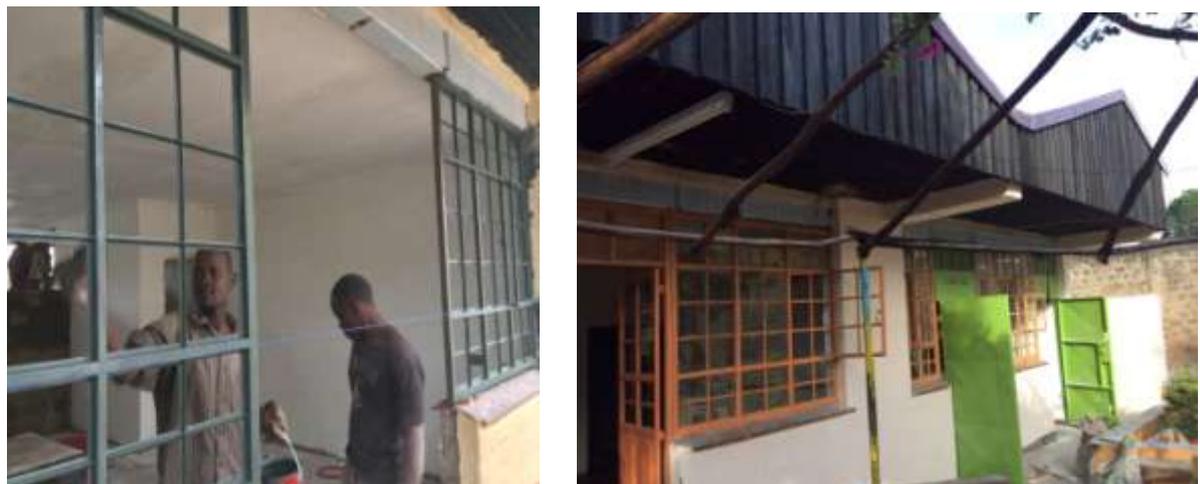
All the old wooden windows were removed and replaced with new aluminium windows, complete with burglar proofing. Skimming with gypsum powder was done for a smooth wall finish and brand new paint was used to give it the new look that it has now.

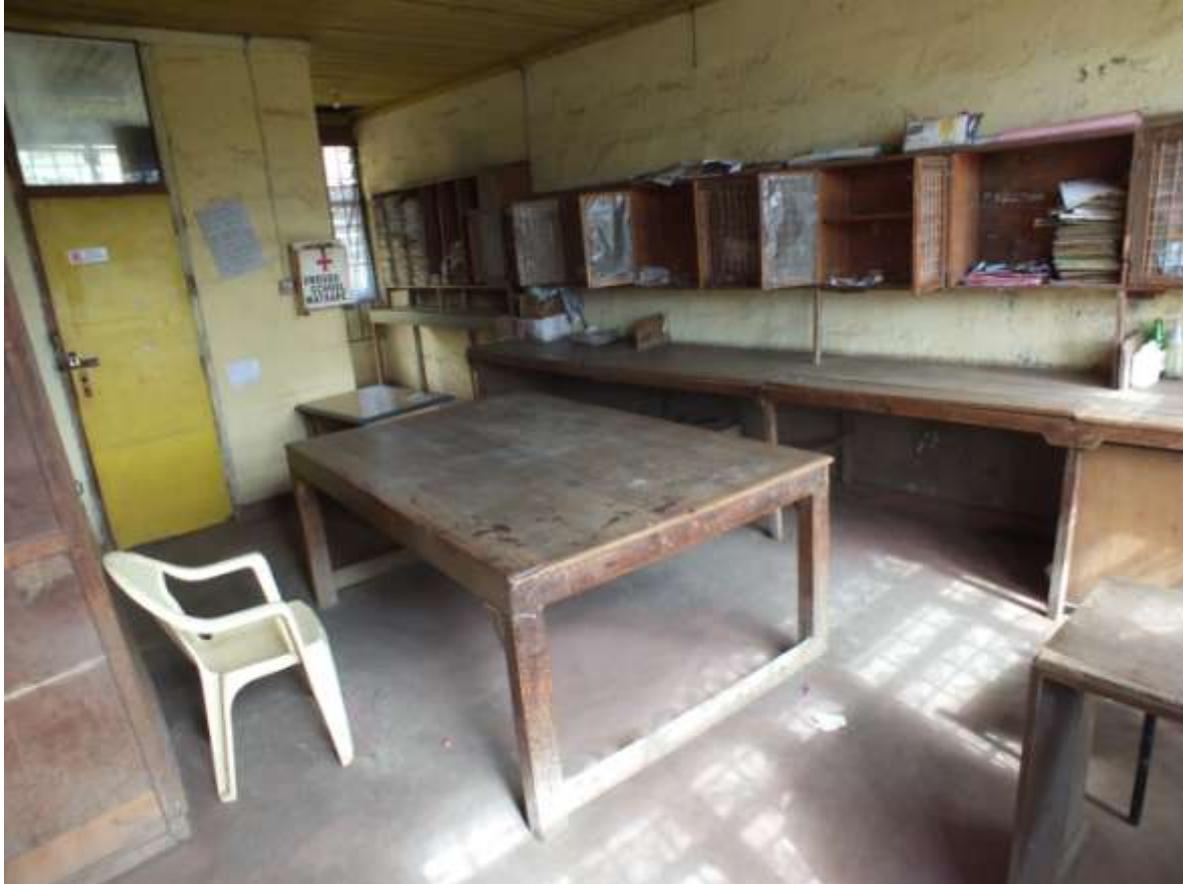
The picture below shows what the old staff room looked like before renovations...

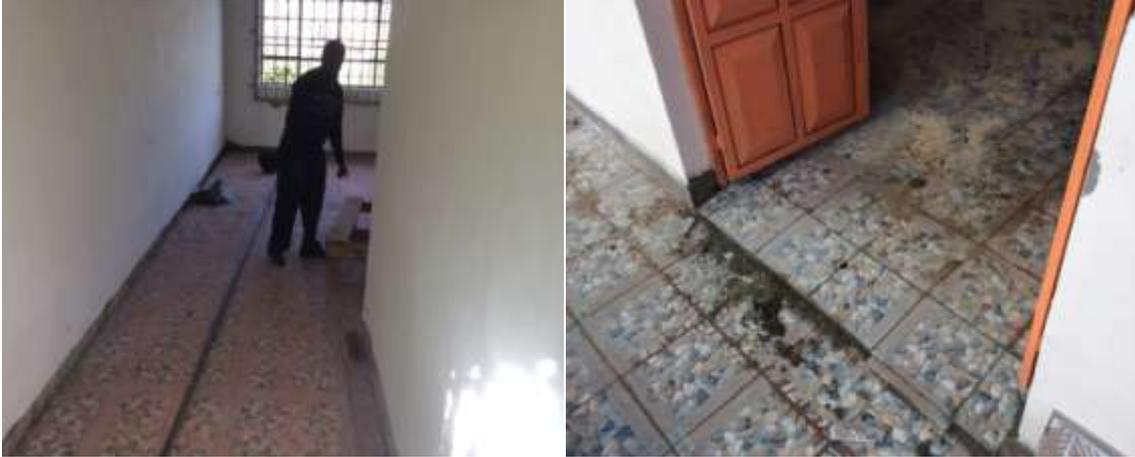
The same high quality floor tiles as were fixed in the tuition block were fixed here too.

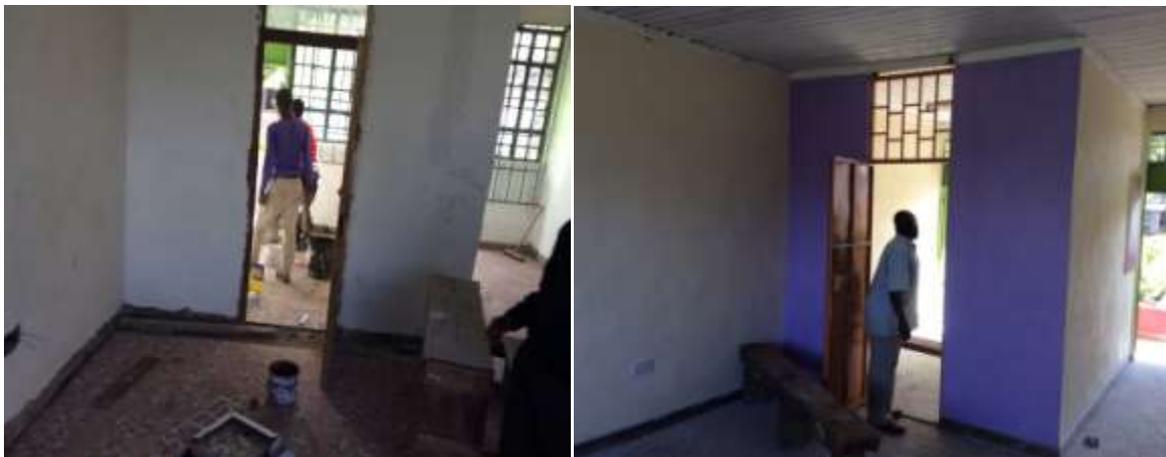
The wooden door that connected this old staffroom to the headteacher's office was removed and replaced with a new metal one for better security. The deputy headteacher and two social workers will have immediate access to the headteacher without having to walk out of the main door to the outside. The dull colours that were in this room have given way to brighter, more attractive colours.

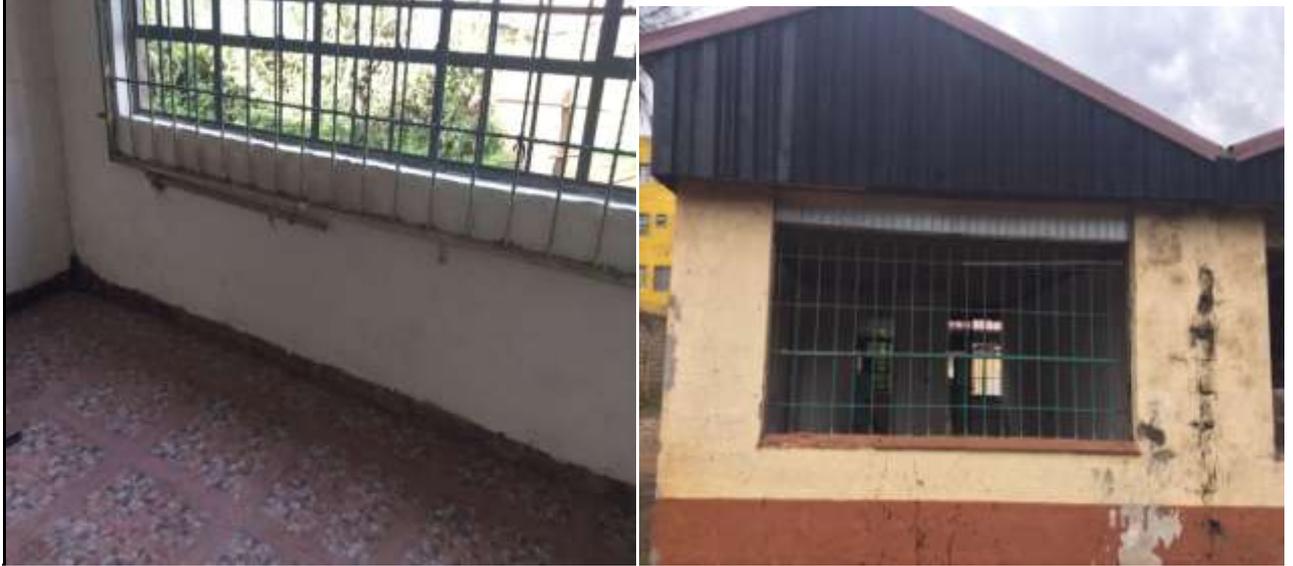
The old staff room already had burglar proofing on its back and front window, so this was retained.

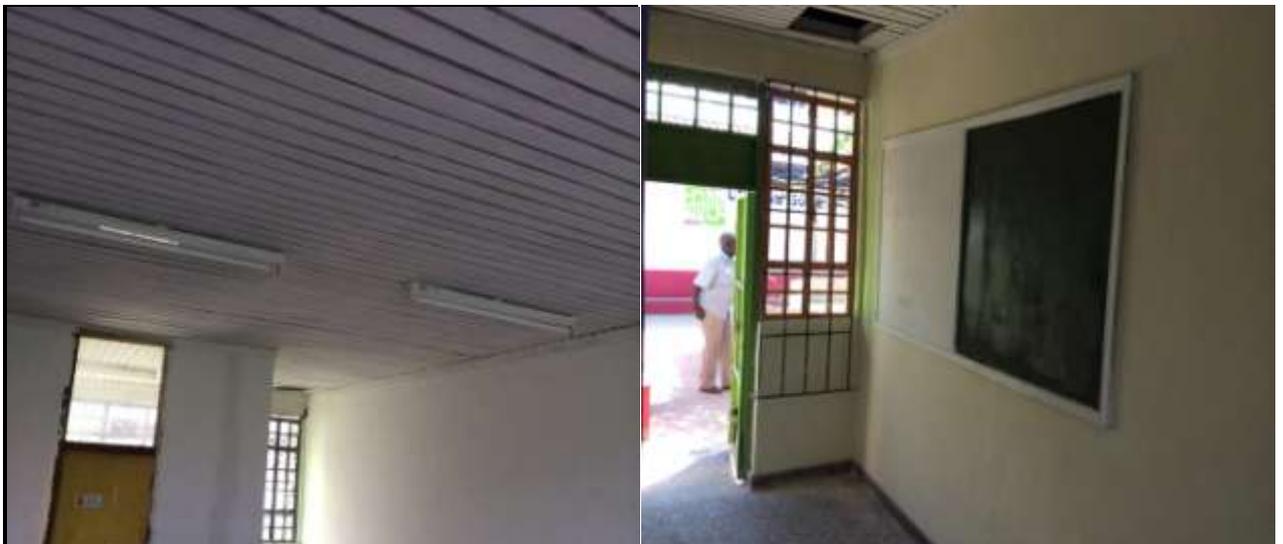
This room already had a ceiling and this was refurbished, with fresh paintwork done. The new electrical system enabled the installation of new florescent lighting tubes. In addition, a chalkboard and softboard were created in this refurbished old staff room for use by the deputy head teacher and social workers.

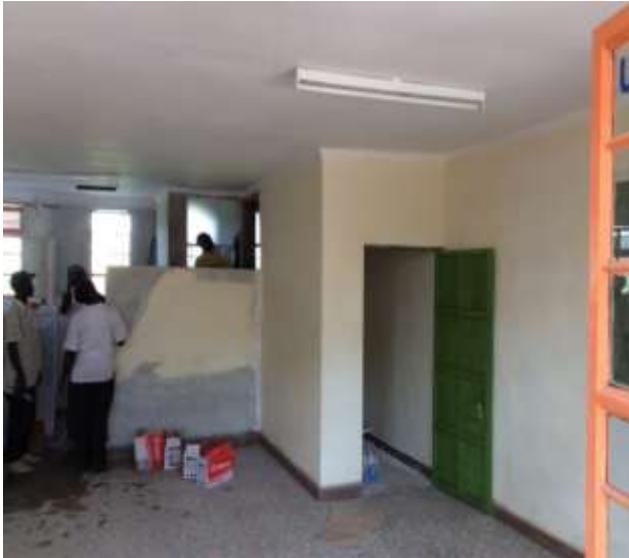
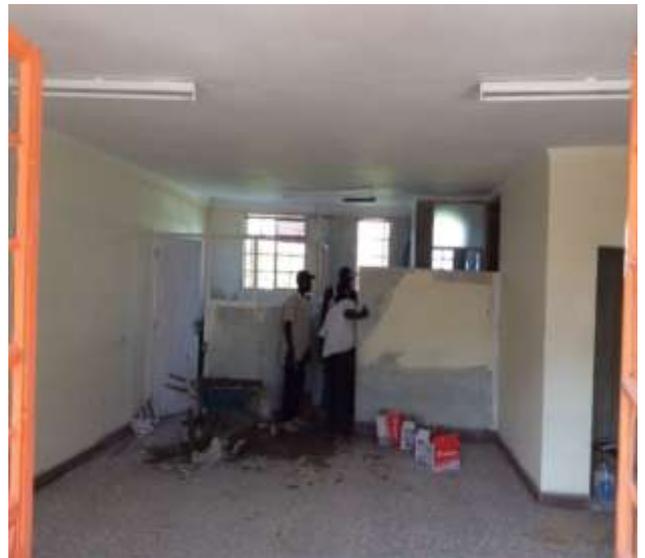
The strong room is almost ready for use. Storage shelves are yet to be created.

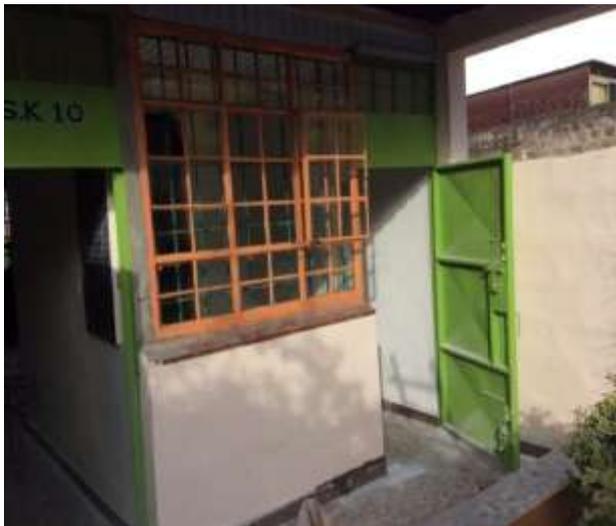
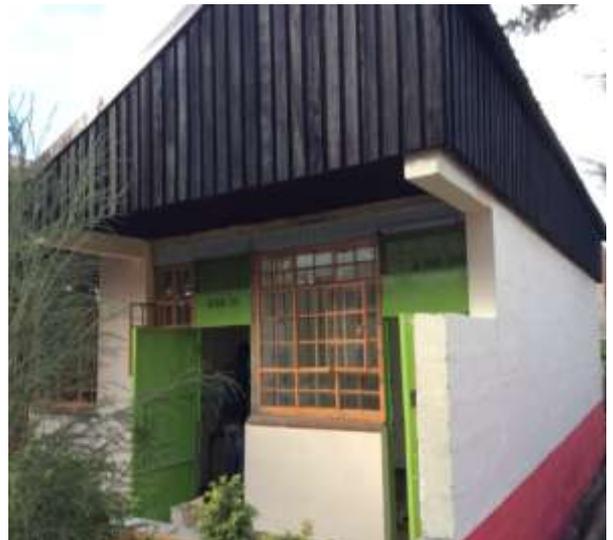
Below is what the external entrance of the Head teacher's office and old staff room looks like after the renovations.
