UNDUGU'S MATHARE SCHOOL RENOVATION PROJECT - 2015

PICTURE GALLERY2-REAR AND SIDE VIEW OF TUITION BLOCK

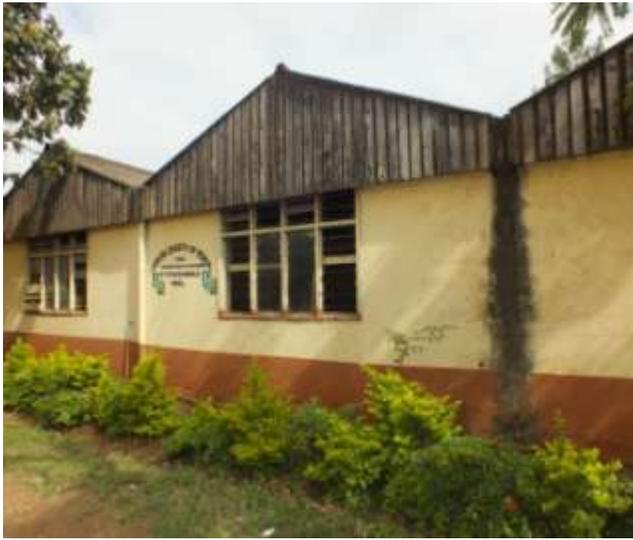
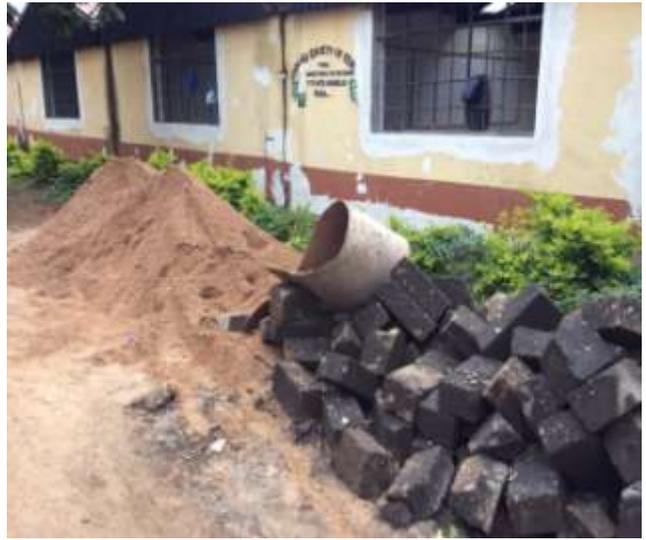
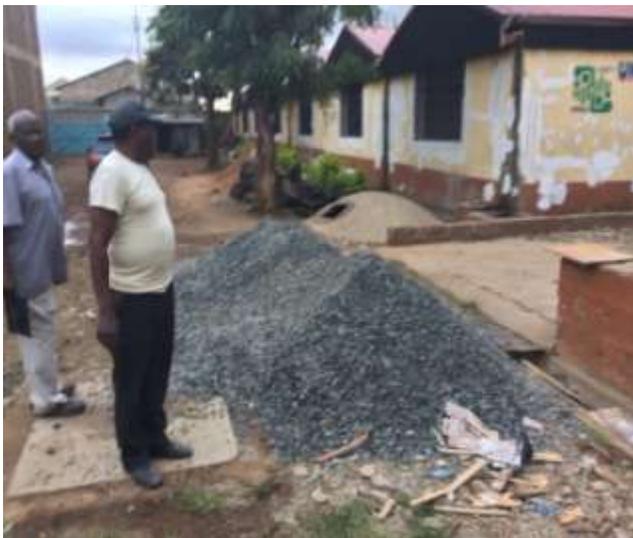
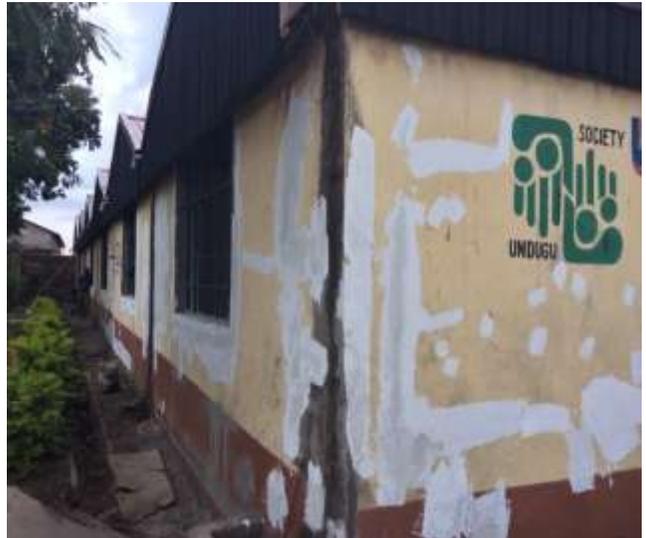
The tuition block rear and side view - at the beginning of the renovations.....

Like the front view of the tuition block the rear side walls collected dust and looked dirty all the time because of the original rough plaster. Rain water from the asbestos roof used to drain onto the wall forming a thick ugly black patch all the way down to the ground. These walls were also smoothed with gypsum plaster.

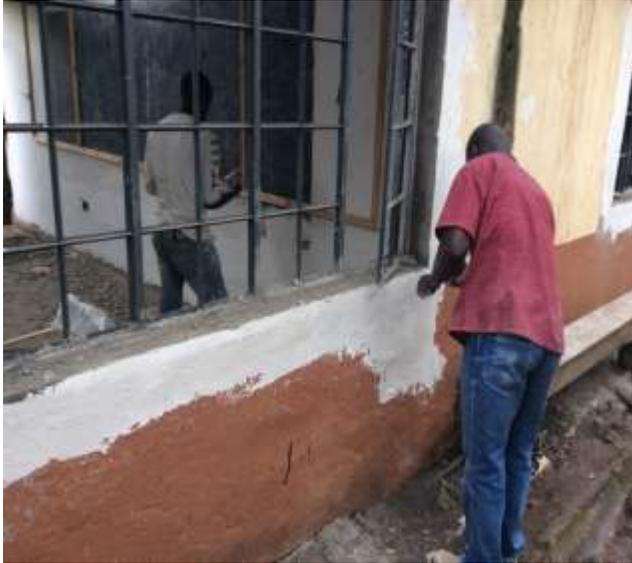
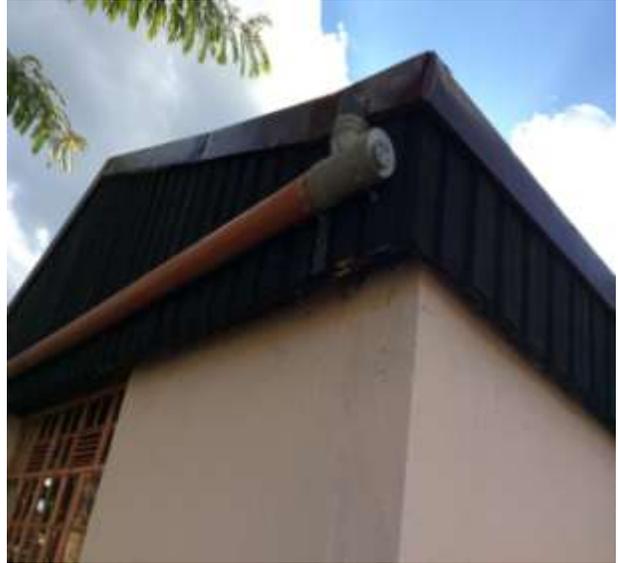
The tuition block rear and side view - during the renovations.....

Once the new aluminium roofs were fixed, gutters were fitted along the edges for the dual purpose of harvesting rain water and preventing the rain water from ruining the painted walls.

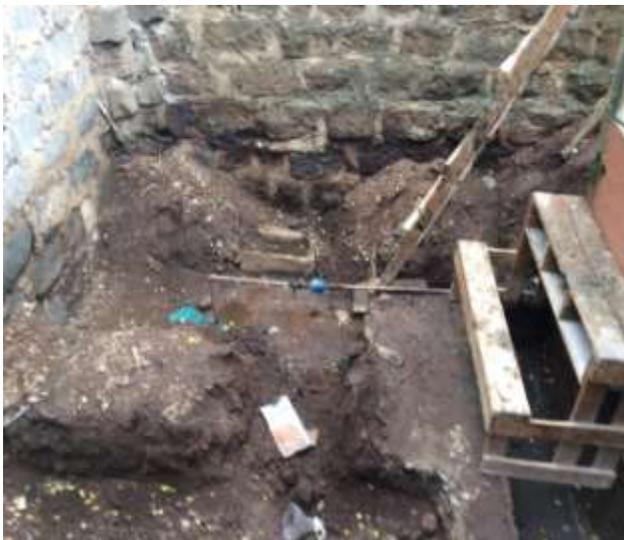
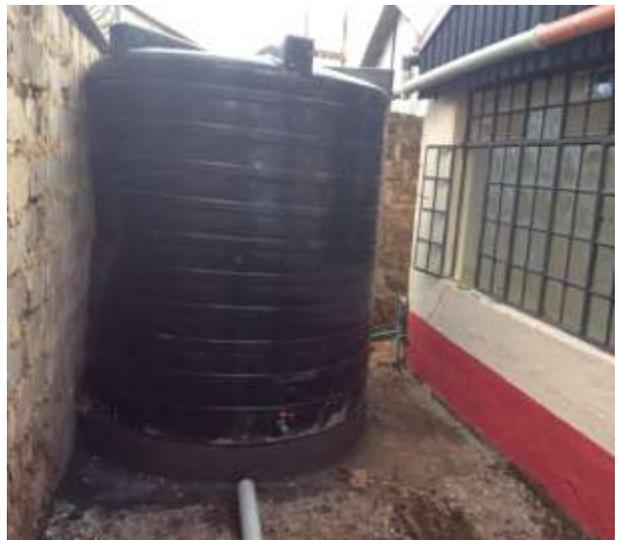
This corner ground below falls on USK's boundary with the neighbour's compound. The renovations saw the excavation of the ground on this corner, followed by the construction of a concrete base for a water tank to sit on. A 10,000 litre plastic water tank was purchased and mounted onto the concrete base.

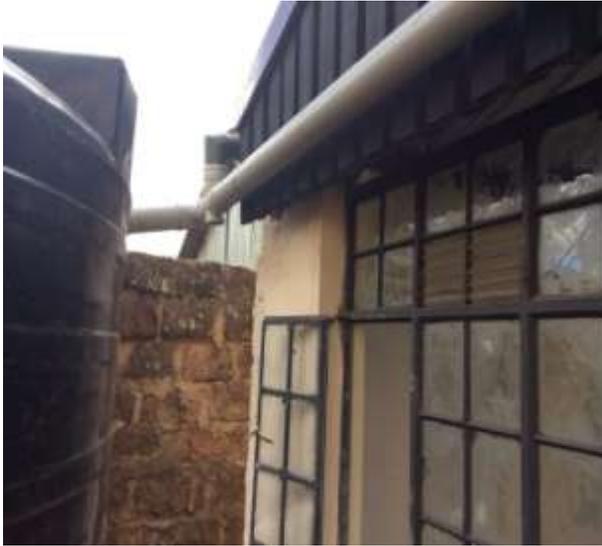
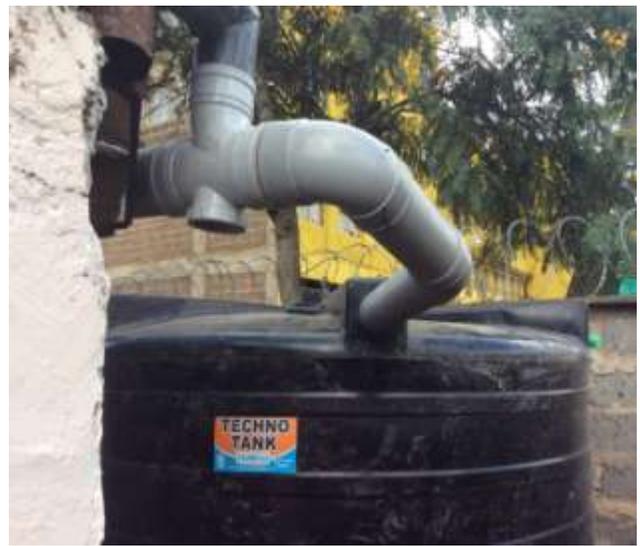
The tuition block rear and side view - rainwater harvesting.....

The gutters from the tuition block roof were connected to new plastic pipes leading to the water tank.

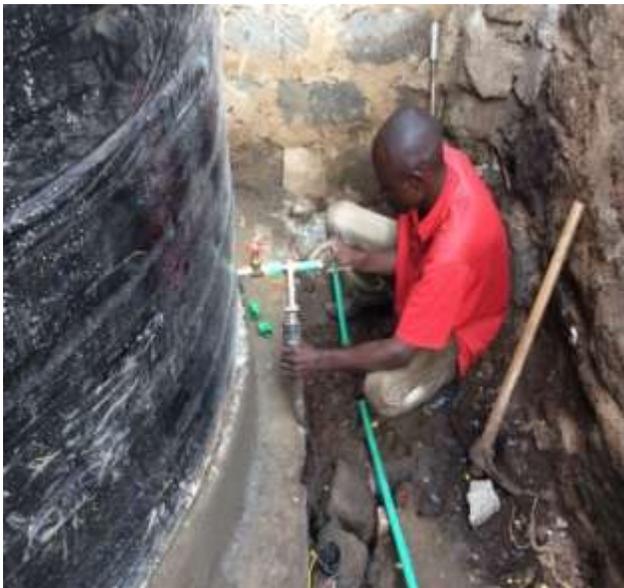
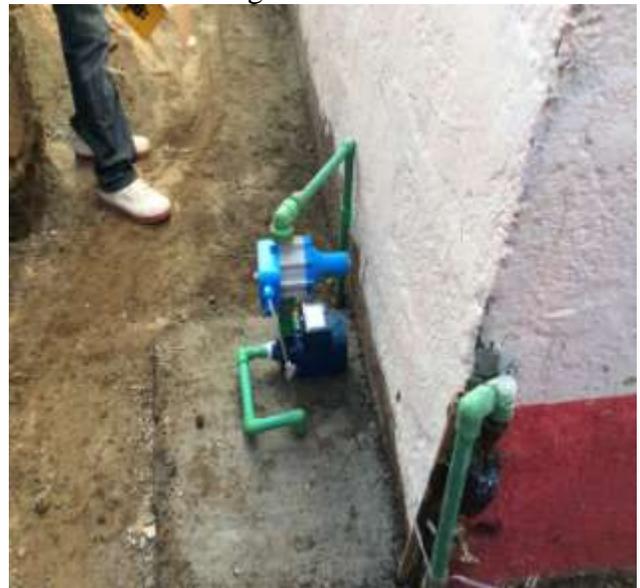
In phase two of the project, this water tank will also be connected by pipes to other smaller water tanks that will be mounted onto a slab that will be created above the toilets. A water pump, complete with a pressure control unit was purchased and has been connected to this main water tank so that when water runs out from the main grid under the Nairobi City County (and these shortages are quite frequent) , the harvested rainwater can serve the abolition block and hand-washing sink area.

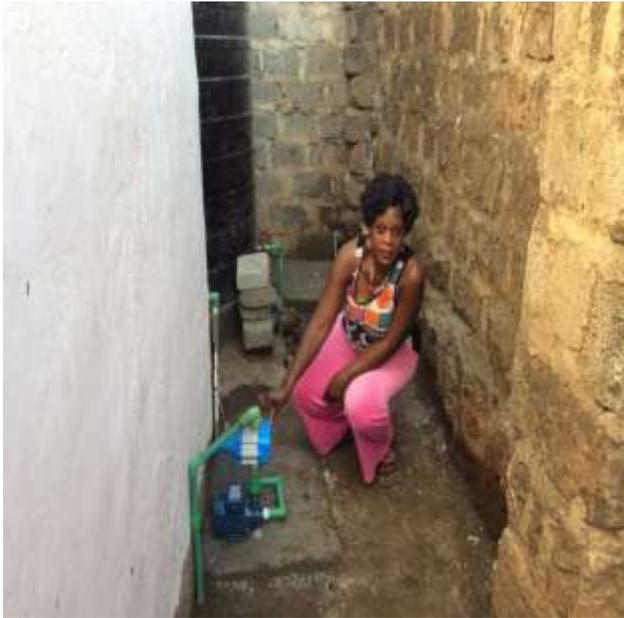
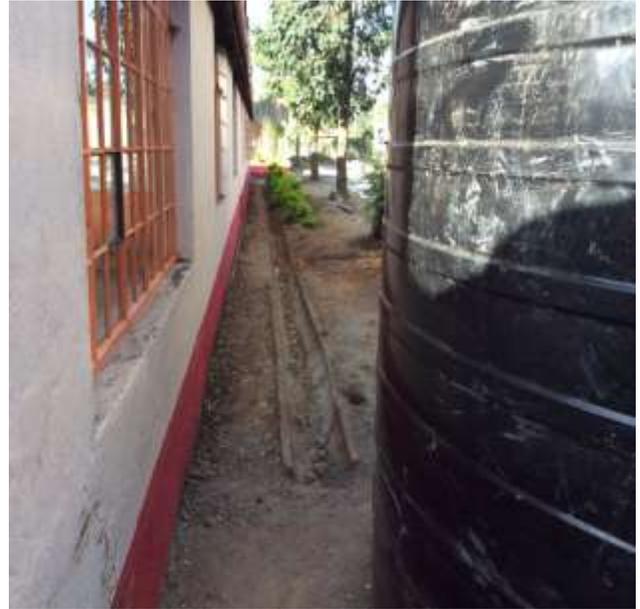
The tuition block rear and side view - rainwater harvesting.....

In phase two of the project, a lockable metal cage will be deter curious children from touching it and prevent thieves from vandalizing it. Below, the new-look rear view of the tuition block. Two days after this tank was connected here, there was a heavy downpour of rain all night and this tank was filled to the brim. The caretaker advises that two more water tanks of similar size should be purchased and connected here, along with four others in other parts of the compound once all the asbestos roofs are replaced with aluminium sheets.

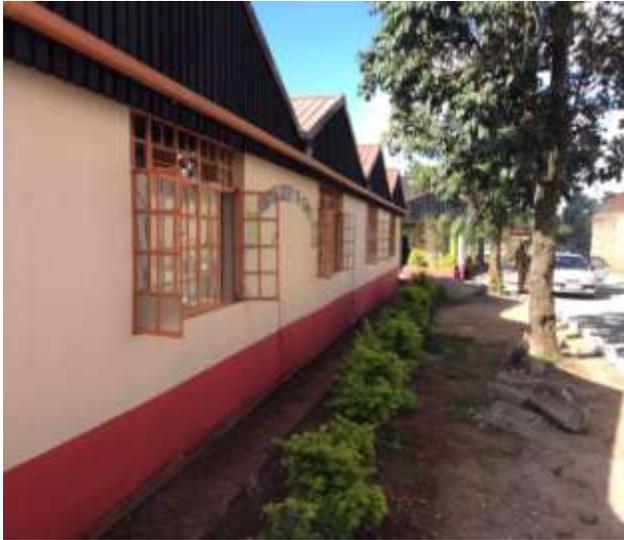
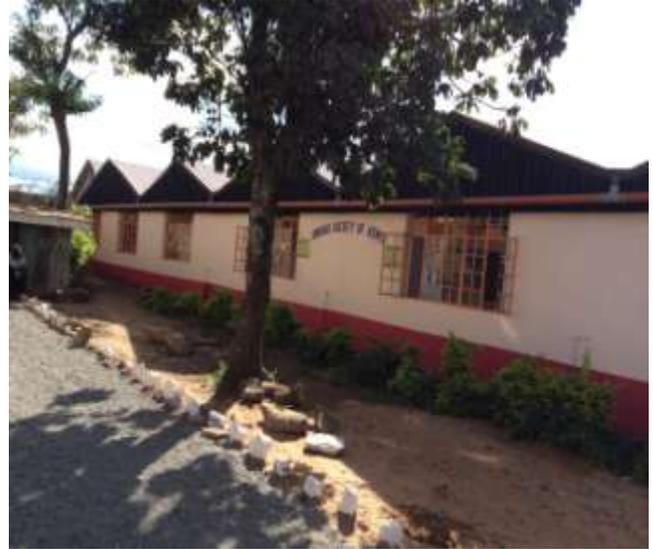
The tuition block rear and side view - near final look.....

This rear view happens to border the driveway from the gate. All the learners in the school come from the neighbouring slum settlements. By the time they reach the school their shoes (or feet...some cannot afford to buy shoes) are covered with either dust or mud. To avoid this dust or mud from making the newly refurbished classrooms dirty, it was necessary (as an afterthought, not provided for in the budget) to improve the pathways in the school by spreading 50 mm ballast or screeding in some sections. Ideally it would be nice to dress these open spaces with carbro pavement or tarmac for a more durable finish but this was not provided for in the budget.

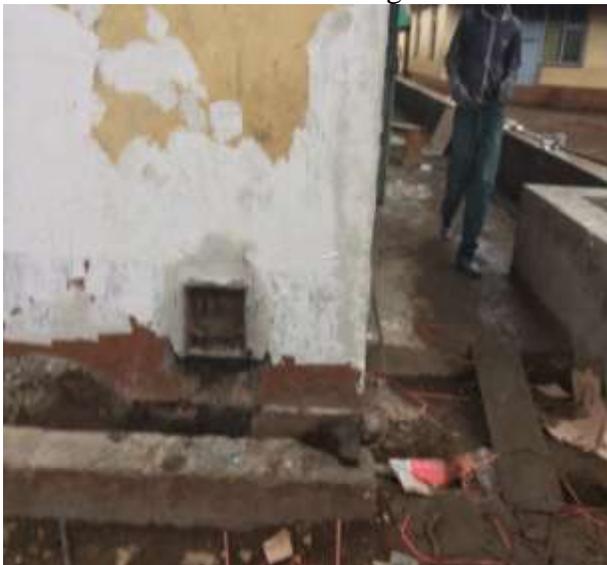
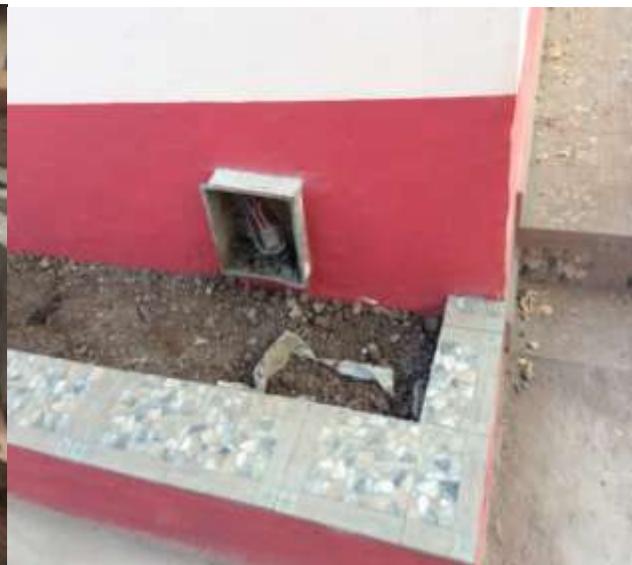
Below are the “before” and “after” pictures of the right hand side of the tuition block, at the entrance into the school from the main gate.

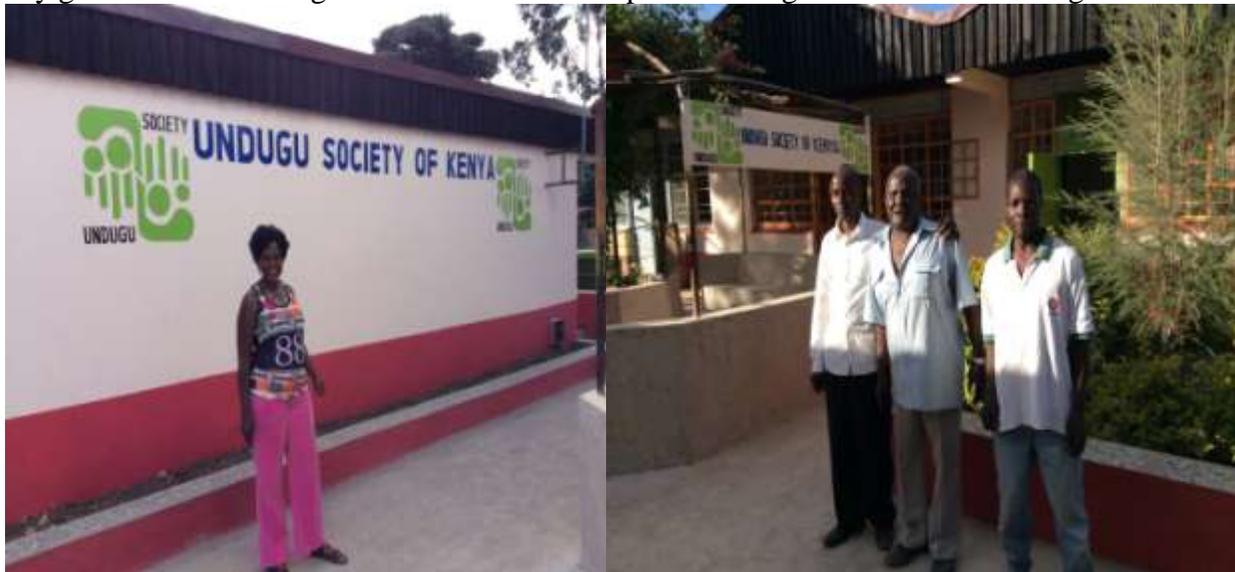
The canopy at the entrance into the compound.

An extra signboard has been created at the entrance, where Father Grol built a canopy over the concrete external bench. The terrazzo finishing on the benches had been roughened and stained over the years by weather and the children climbing on it. These renovations saw the polishing of the terrazzo surface of the benches making them look freshly done.
