UNDUGU'S MATHARE SCHOOL RENOVATION PROJECT - 2015
PICTURE GALLERY - THE FRONT PART OF THE TUITION BLOCK

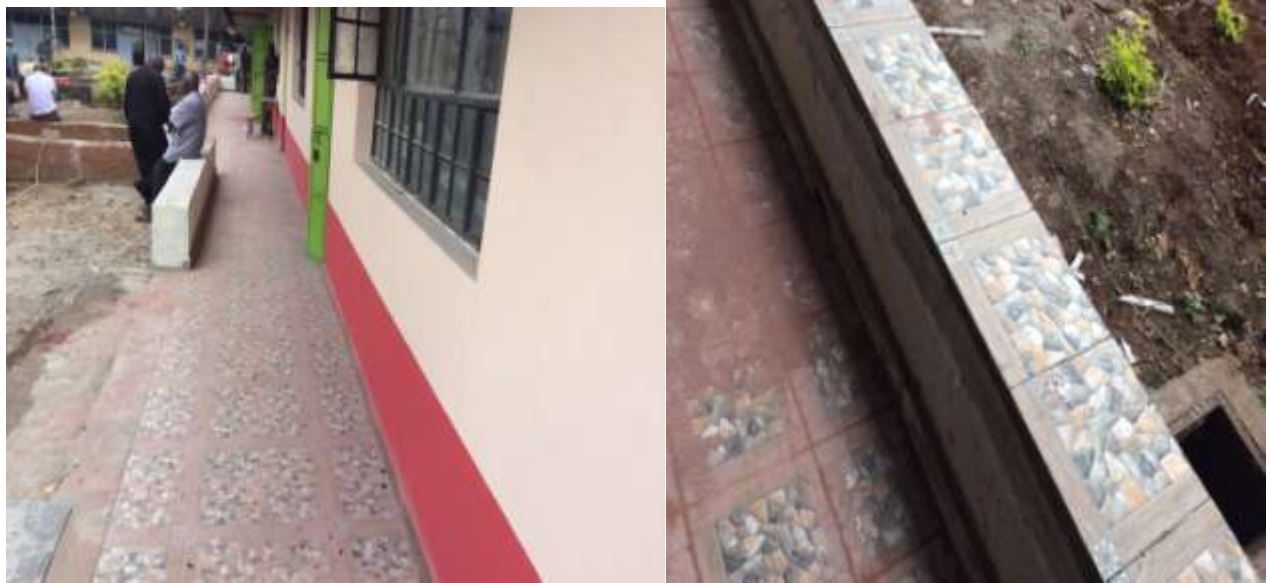
THE NEW-LOOK EXTERNAL TUITION BLOCK CORRIDORS...

The corridors were worn out and full of potholes. The worn out screed here was removed and fresh screeding done after which they were dressed with ceramic tiles (with matching skirting against the walls) spilling out from the new-look classroom floors described elsewhere in this report.

Strong high-quality non-slippery ceramic tiles were purchased

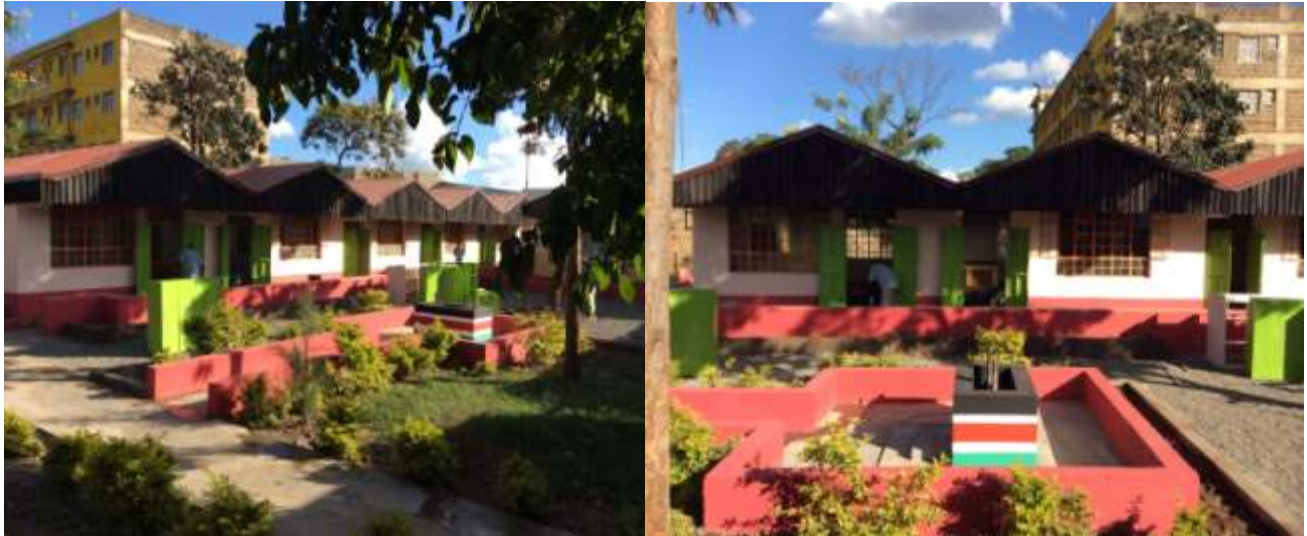
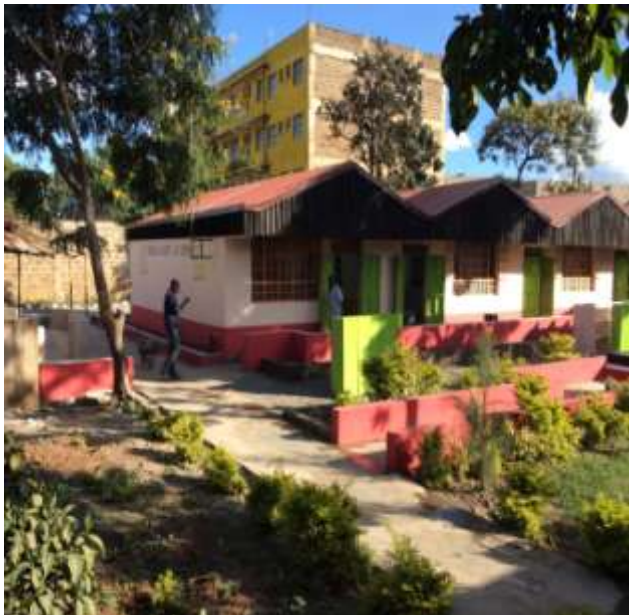
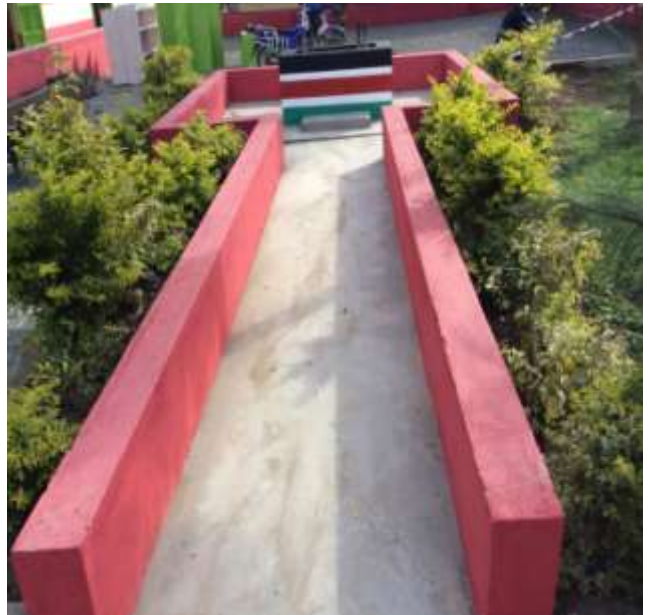
Tuition block front elevation – after renovations – near final look.....

Bright, attractive and child-friendly colours (peach, red, orange and lime green) have been eventually combined to achieve a great effect that is expected to improve the general learning environment for more motivation of the children. Renovations to the surrounding grounds, footpaths and the flapost/assembly area have also now been initiated and are almost complete.
